APPENDIX D: SECTION N2 INDUSTRIAL PROPERTY INFORMATION

Environmental Conditions at US Hwy 190 Bridge Crossing

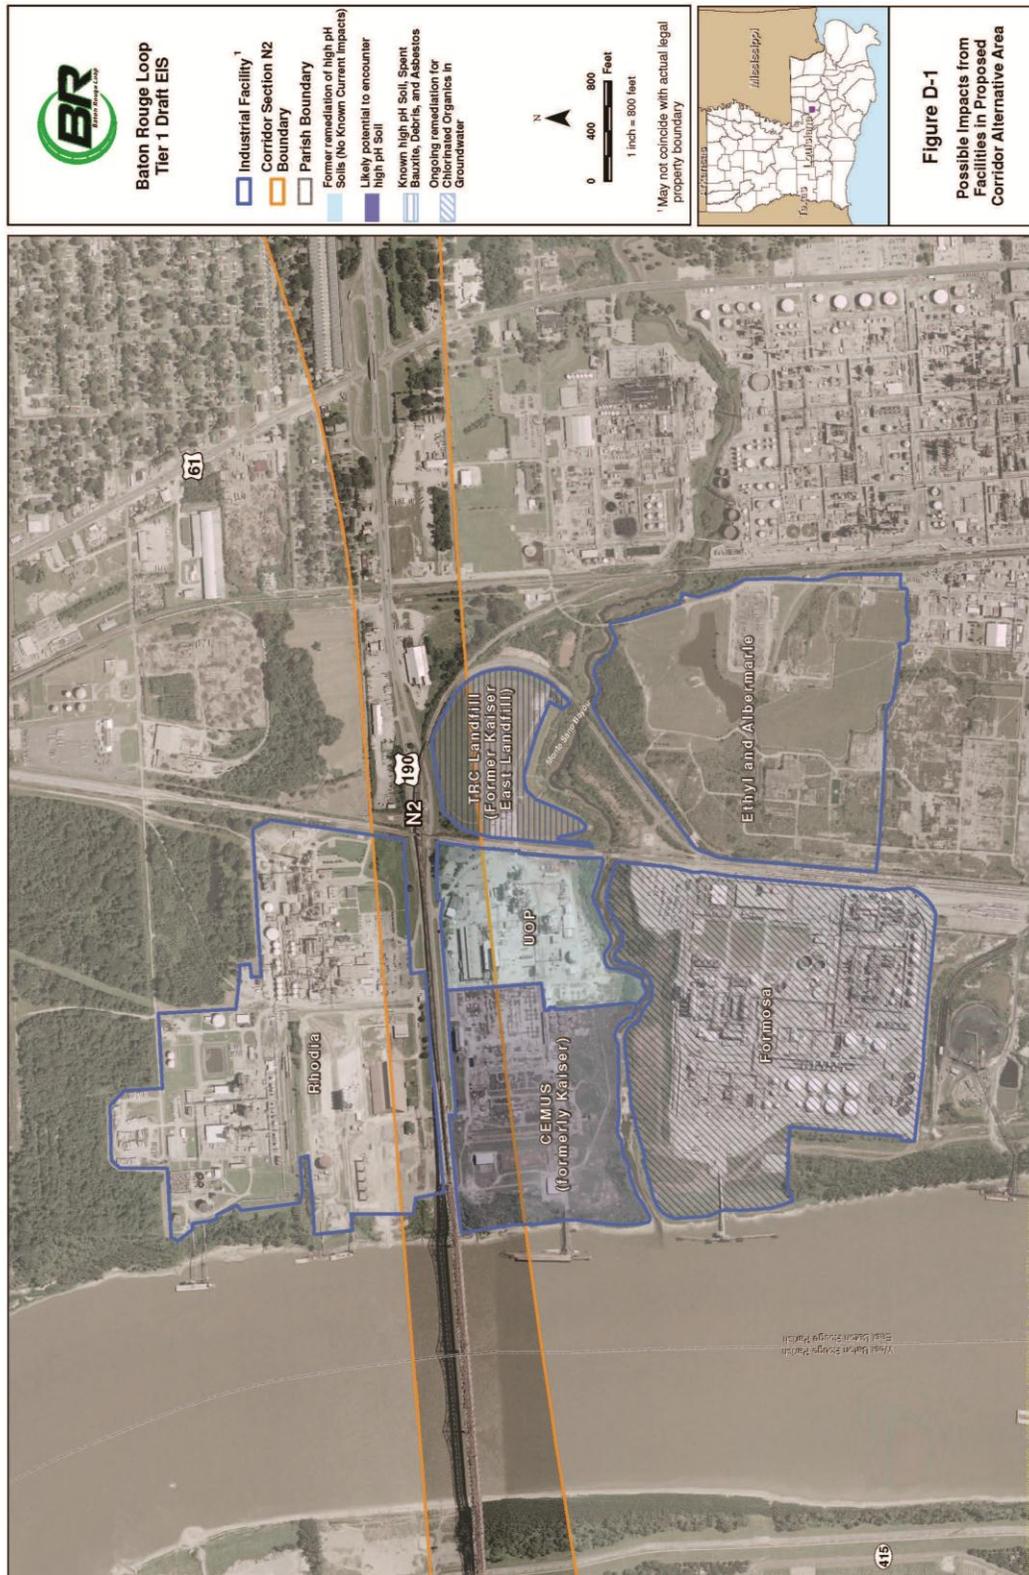
Figure D-1: Potential Facility Impact Area

Figure D-1 shows known sources in the industrial area surrounding the US Hwy 190 Bridge crossing that could potentially have impacts on Corridor Section N2.

The former Kaiser Aluminum facility is located on approximately 60 acres directly to the east of the Mississippi River and to the south of US Hwy 190 (Figure D-1). At one time, the Kaiser facility also included the current UOP property (discussed below) and the Kaiser East Landfill, which is located directly south of US Hwy 190 to the east of the current UOP facility as shown on Figure D-1. It should be noted that the facility boundaries on Figure D-1 may not exactly coincide with the actual legal boundaries.

The UOP facility is located on approximately 50 acres south of US Hwy190, between the former Kaiser facility and the Kaiser East Landfill (Figure D-1). It is an inorganic chemical plant that manufactures specialty grade alumina trihydrate and reduction grade alumina ore. The plant was originally built in the 1940s for the U.S. Department of Defense and was later operated by Alcoa. Kaiser purchased the plant in the 1960s. LaRoche Industries purchased a portion of the plant from Kaiser in 1988. UOP acquired the facility from LaRoche in June 1999.

The Ethyl facility is located on 193 acres to the south of the Kaiser landfill as shown on Figure D-1. Monte Sano Bayou flows through the north portion of the property. Ethyl was an active chemical plant from 1937 to 1985. In 1985, the manufacturing operations were shut down. Current manufacturing on the property is limited to the southeastern corner where Albemarle Corporation conducts research and pilot plant operations. Historical chemical production and/or use included chlorine, sodium, tetraethyl lead, solvents (including ethylene dichloride, perchlorethylene, methylene chloride, methyl chloride, carbon tetrachloride, and chloroform).

The Rhodia Baton Rouge Facility occupies approximately 100 acres of land to the north of US Hwy190, east of the Mississippi River as shown on Figure D-1. The Baton Rouge Facility manufactures sulfuric acid, liquid sulfur dioxide, synthetic vanilla, hydroquinone, pyrocatechol and veratol.

Formosa operates a chemical manufacturing facility on approximately 130 acres south of the CEMUS and UOP sites as shown on Figure D-1. The facility is south of Monte Sano Bayou and adjacent to the Mississippi River. Therefore, the facility is outside of the footprint of where the bridge would likely be constructed. If there were any impacts to the area of planned bridge construction resulting from Formosa, it would likely be from contaminated groundwater that had migrated from the site to the potential bridge construction area.

The information and interpretations provided in this document are based on a limited review of selected available documentation in the LDEQ files. The intended purpose is to provide a general overview of the environmental conditions at these industrial facilities for planning purposes. The regulatory interpretations for disposal options and costs are also of a general nature and may not reflect site-specific conditions that were not identified in the review. It should be noted that property boundaries in Figure D-1 may not coincide with actual legal property boundaries.
